Birch Lake

Stormwater Retrofit Analysis

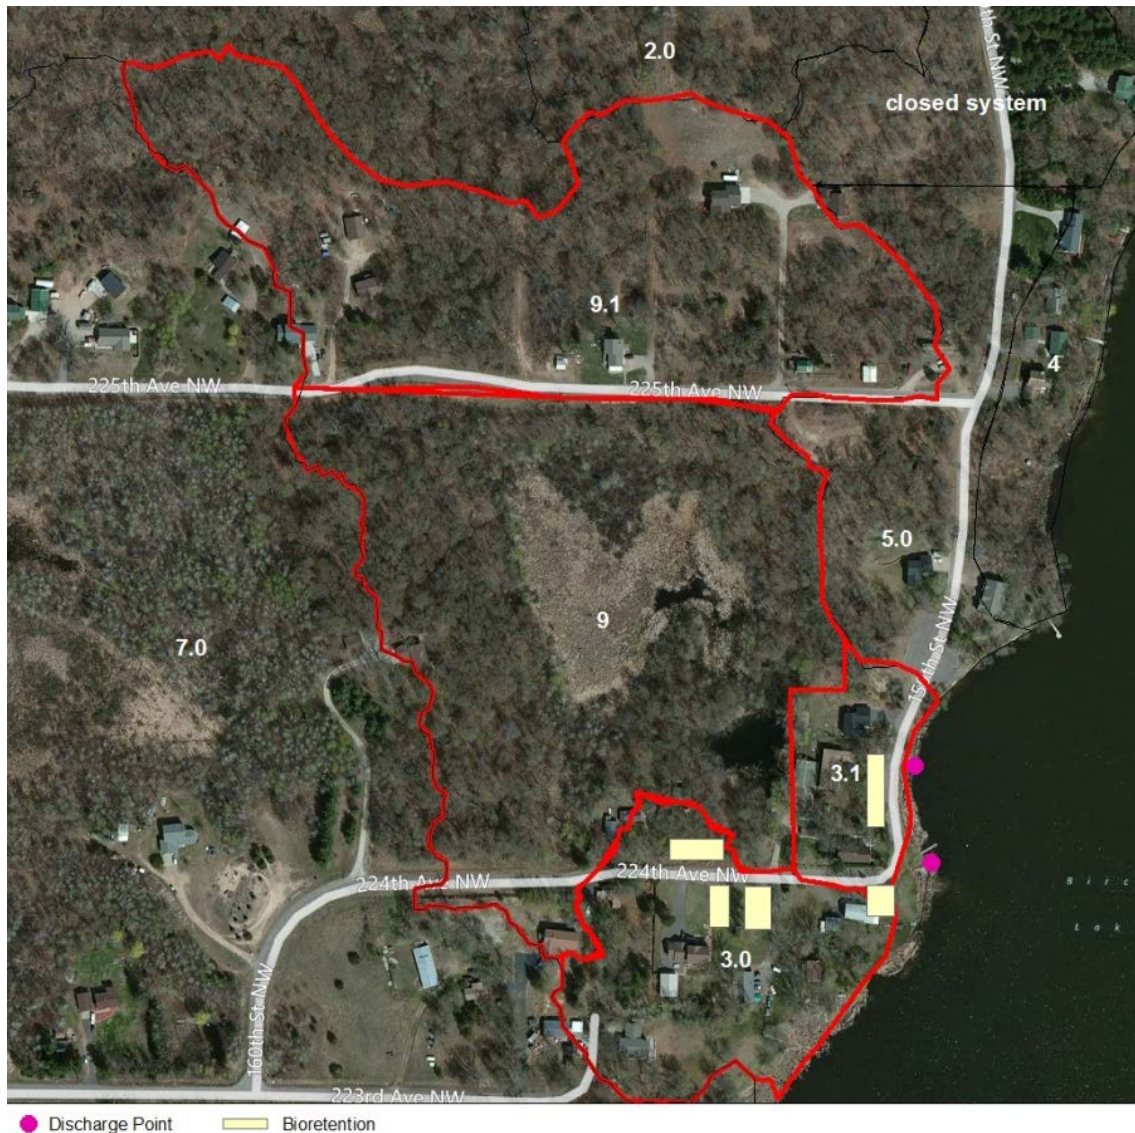
Volume and pollutant reductions resulting from practices described are highlighted in the table and locations shown in the map below.

SC3 & SC3.1: It is recommended to slow or intercept the accumulation of water moving down 224th avenue by redirecting water into a series of infiltration basins (most likely rain gardens) on privately owned properties. Five optimal rain garden locations, sized to a minimum of 250 square feet each, were identified (see map below), thus we analyzed a scenario where all five rain gardens were installed in SC3 and SC3.1. There may also be an opportunity to divert some of the flow into the township easement into the wetland system or a swale off of 224th. There are likely additional opportunities for infiltration basin placement within this catchment; thus, a scenario with 10 raingardens was also developed. Volume and pollutant reductions resulting from the rain garden installations are highlighted in the table below.

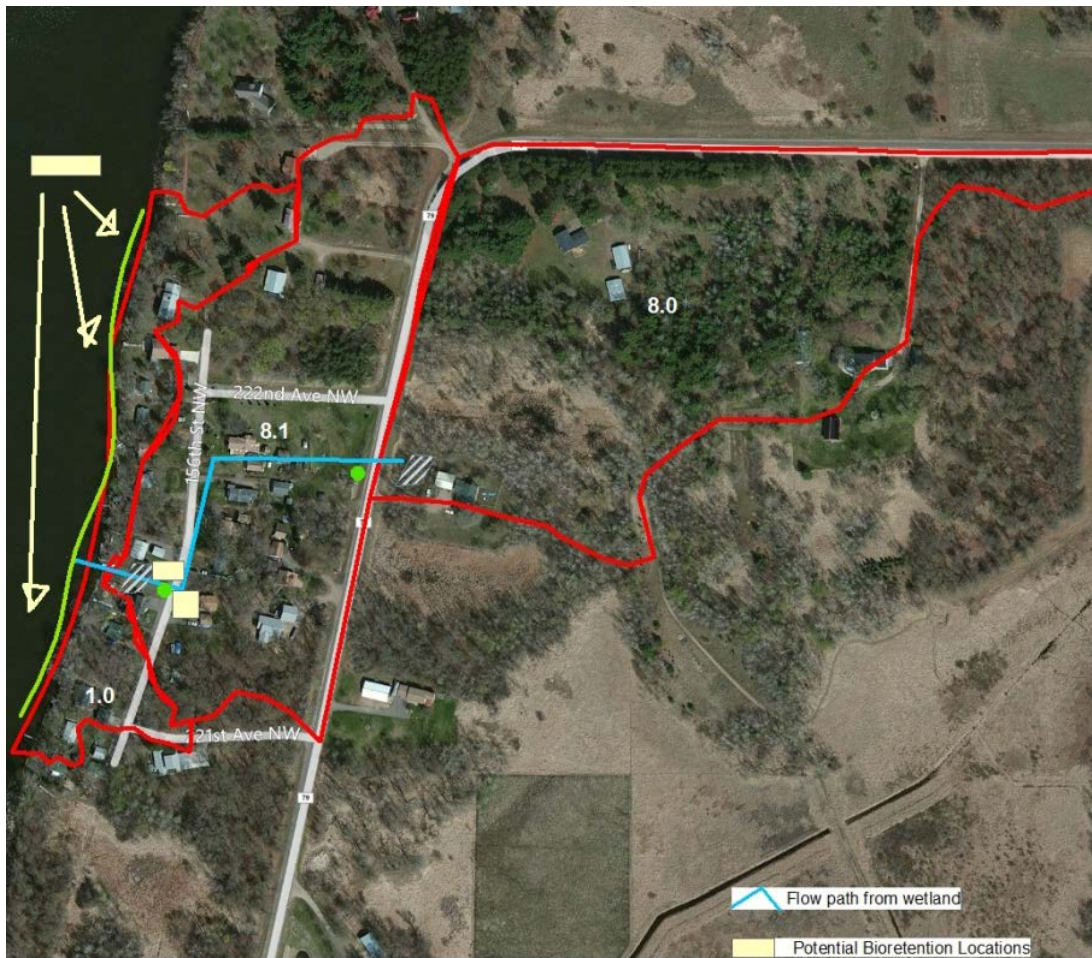
Volume and pollutant reductions resulting from practices described are highlighted in the table and locations shown in the map below.

● Recommended Monitoring Location
 Iron Enhanced Sand Filter-Potential Locations
⤵ Lakeshore Restoration Locations

SC 8.1: Two ideal locations for bioretention practices were located in SC8.1. We analyzed a scenario with both 500 square feet of infiltration practices and another with 1,000 square feet in SC8.1 assuming that there are additional ideal locations for bioretention.

SC 1.0: Most defiantly there are opportunities for lakeshore restoration along each shoreline property; thus analyzed a scenario with lakeshore restoration covering 1000 linear feet of shoreline along all parcels within the SC1.0. Each lakeshore restoration was assumed to be a minimum of 15 feet wide and to cover a minimum of 75 % of each lakeshore property. Shoreline is critical for fisheries, water quality and overall ecology. While pollutant reductions from lakeshore restorations are not great, the approach still deserves serious consideration as these projects do provide multiple, valuable benefits including: protection against erosion, filter yard runoff before it enters the lake, and provides fish and wildlife habitat.

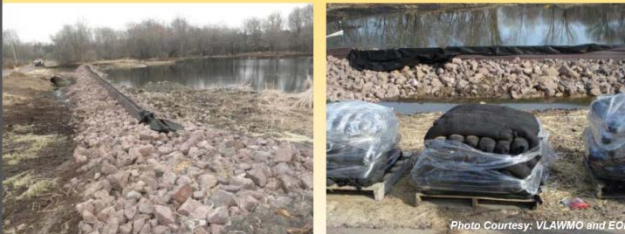
- Permeable Weir:

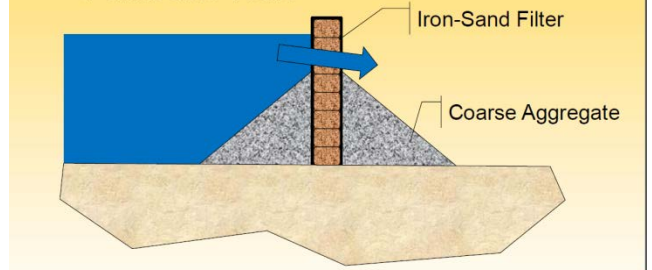
- Permeable Weir:

Iron-Sand Filter
Coarse Aggregate

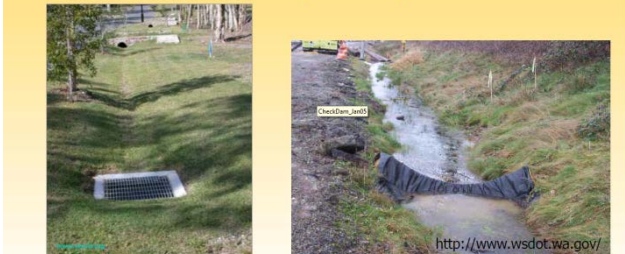
- Roadside ditches (swales):

Check Dam (weir)

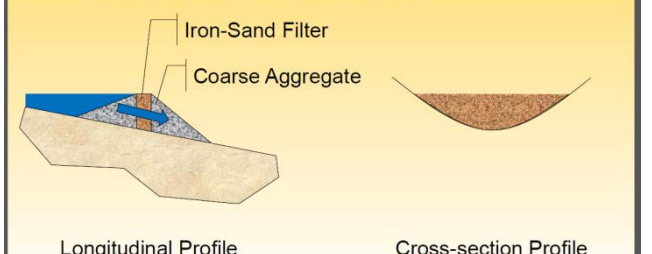
- Roadside ditches (swales):

Iron-Sand Filter
Coarse Aggregate

Longitudinal Profile Cross-section Profile

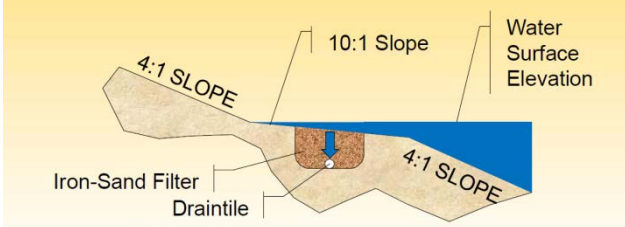
- Wet Detention Pond:

10:1 Slope
4:1 SLOPE
Water Surface Elevation
Iron-Sand Filter
Drain tile

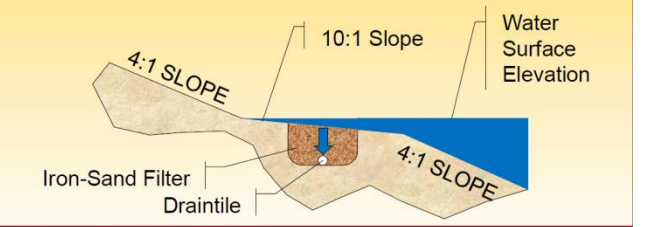
- Wet Detention Pond:

10:1 Slope
4:1 SLOPE
Water Surface Elevation
Iron-Sand Filter
Drain tile

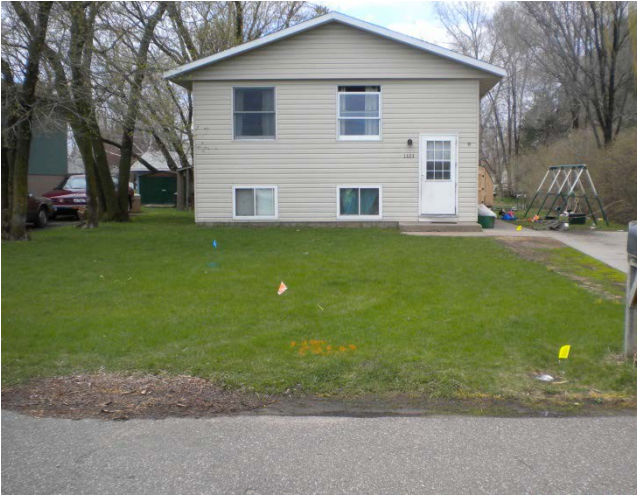
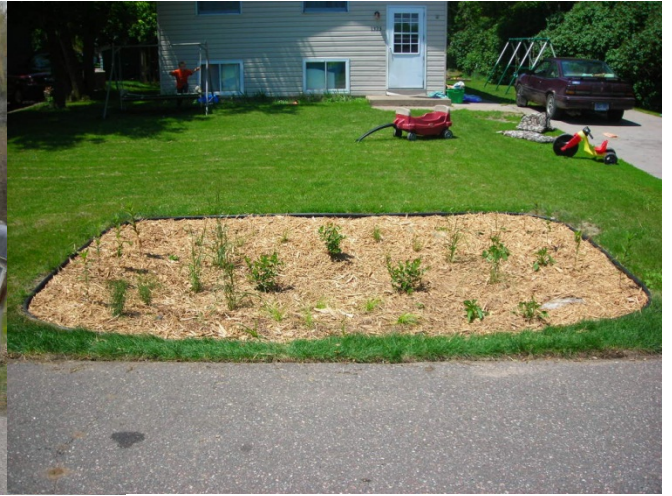
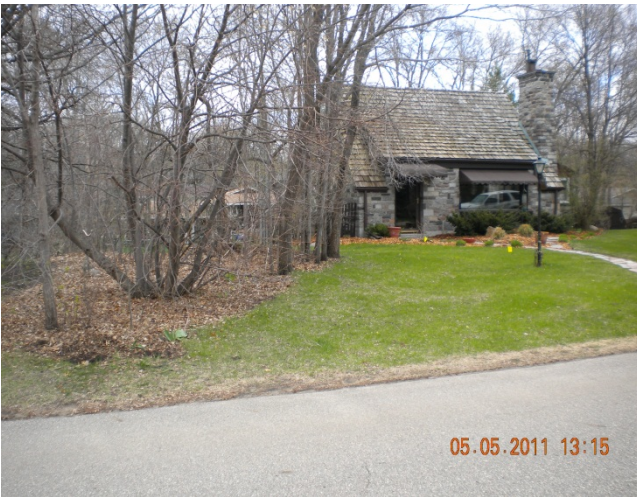
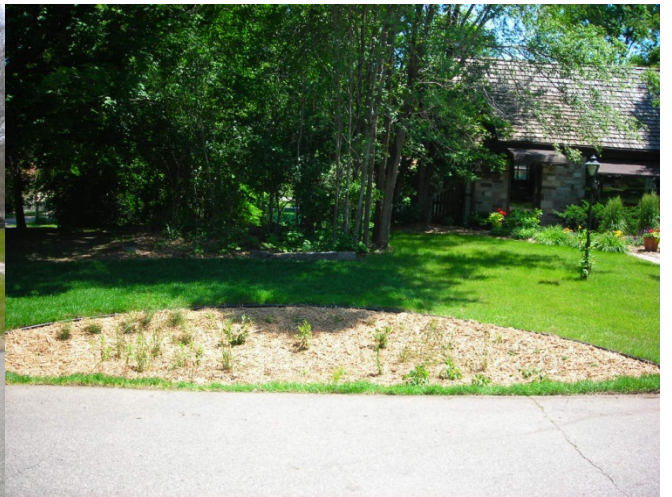
2) Bioretention Concepts

City of
St. Cloud Rain Garden Retrofits

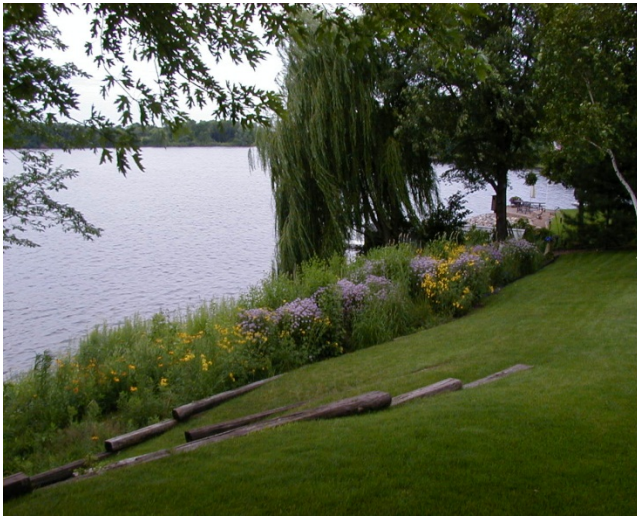
Pictured above: Orono Lake Shoreline Buffer

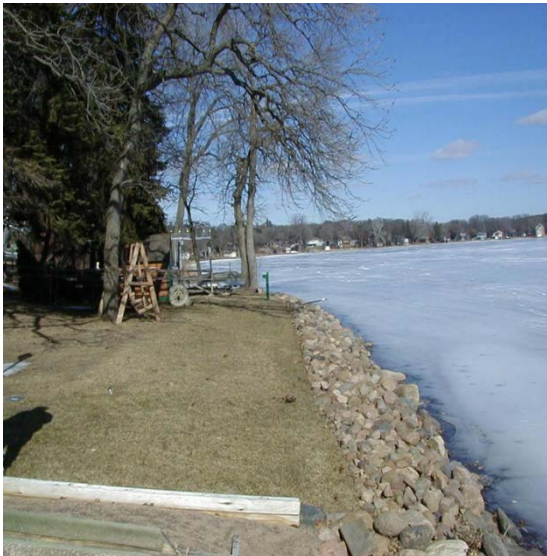
Pictured above: Briggs Lake Chain Shoreline Buffer (Before and After)
