Blue Lake Stormwater Retrofit Analysis

Isanti Soil and Water Conservation District And Sherburne Soil and Water Conservation District

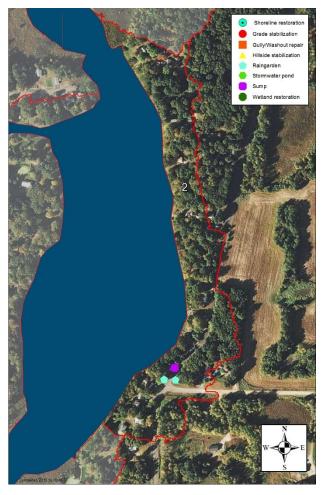
Existing Sub-Catchment Summary		
Acres	1.07	
Dominant Land Cover	residential	
Volume (acre-feet/yr)	0.562	
TP (lb/yr)	0.5364	
TSS (lb/yr)	140

Location – 8771 285th Ave NW (See Map)

phosphorus among all projects identified in this assessment. The proposed project is a curbcut raingarden installed in a residential yard. The raingarden would collect and infiltrates curbside stormwater from the township road and surrounding landscape. The garden is designed to hold water for no more than 48 hours after a storm, but the ponding time is often much shorter in areas with sandy soils. When the raingarden is full, water will flow into the retrofitted extension pipe on the beehive storm drain currently located at the site.

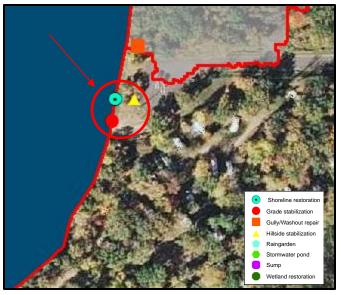
Current Site Conditions

277th Avenue NW ends at the Stanford Township boat access. A 9,500 sq. feet mowed grass area sits between the parking area and the lakeshore. The bottom of the hill offers 150 linear feet of flat shoreline, a desirable area for onshore fishing. The combination of the hill's slope, short vegetation and excess foot traffic has resulted in moderate to severe hillside erosion and gully formation. Restoring the hillside and repairing the existing gully with designed landscaping and native vegetation plantings will eliminate soil loss and nutrient loading by stabilizing the hillside and filtering overland flow. Installing stairs from parking lot to the boat launch outlet will minimize impact caused by foot traffic.

The 150 feet of linear shoreline was targeted during the shoreline boat survey as a high priority site as well as during the on shore assessment. The shoreline's eroding face is an average of 1ft high nearly void of vegetation and has some undercutting and vegetative overhang. A vegetated buffer with a minimum 15ft width along the entire length of shore line is proposed for this area. Intermediate open areas can offer access to those wishing to fish from the shore.

Gully/Hill/Shoreline Restoration and Repair							
	Cost/Removal Analysis	New Treatment	% Reduction					
	Number of BMPs	3						
Treatment	Total Size of BMPs sqft	5,000.0						
atn	TP (lb/yr)	6.24	100.0%					
Tre	TSS (lb/yr)	13,297	100.0%					
	Volume (acre-feet/yr)	119.40	1.7%					
	Administration & Promotion Costs*	\$3,986						
Cost	Design & Construction Costs**	\$19,312						
ပိ	Total Estimated Project Cost (2016)	\$23,298						
	Annual O&M***	\$70						
сy	30-yr Cost/lb-TP	\$237						
Efficiency	30-yr Cost/1,000lb-TSS	\$111						
Eff	30-yr Cost/ac-ft Vol.	N.A.

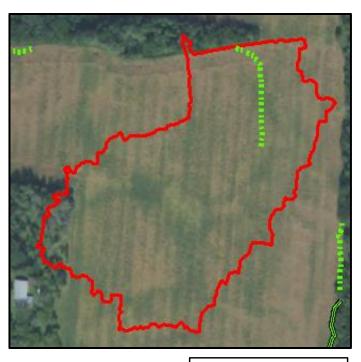
Project ID – Grassed Waterway Zone 2 Sub-Basin 1

Drainage Area – 11.1 acres Property Ownership – Private Site Specific Information – Moderate slopes within field. Aerial photos indicate row cropping. Potential for gully formation at the north end of the basin. This is a good opportunity to implement a grass waterway to prevent erosion and nutrient loss.

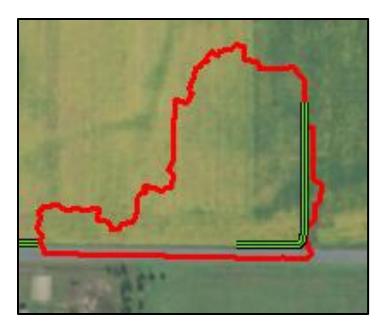
Drainage Area – 3 acres Property Ownership – Private Site Specific Information – Moderate slopes make an edge of field filter strip a good option. Assuming the area is row cropped (based on aerial photos) the filter strip would catch any sediment and nutrients prior to reaching the ditch. Possible ditch along the roadside.

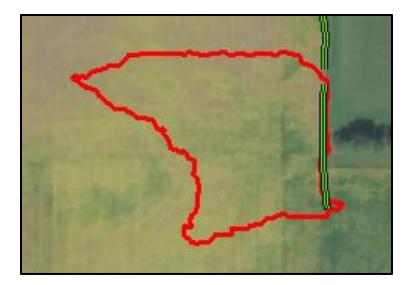
Drainage Area – 3.6 acres Property Ownership – Private Site Specific Information – With moderate slopes and row cropping as the land use, an edge of field filter strip would reduce sediment and nutrient loading. The entire basin is row cropped.

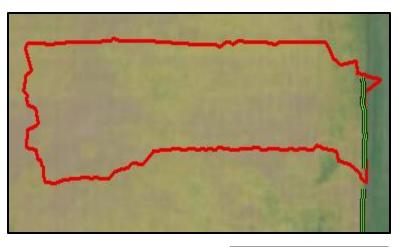
Drainage Area – 3.5 acres Property Ownership – Private Site Specific Information – With moderate slopes and row cropping as the land use, an edge of field filter strip would reduce sediment and nutrient loading. Connecting to the filter strip in sub-basin 9 (to the south) would increase the benefits of the practice.

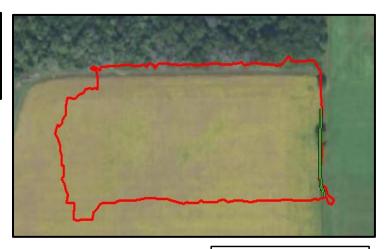
Drainage Area – 6.7 acres Property Ownership – Private Site Specific Information – With moderate slopes and row cropping as the land use, an edge of field filter strip would reduce sediment and nutrient loading as well increase the biodiversity in the area. To the east of the basin is another row cropped field and to the north is wooded area.

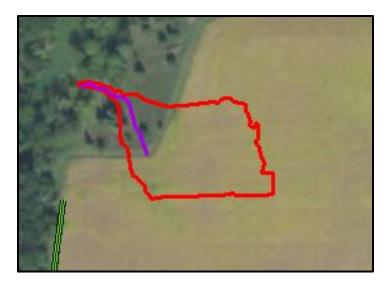
Drainage Area – 1.3 acres Property Ownership – Private Site Specific Information – Visible gully formed just off of the field at NW portion of basin. Address with perennial grassed waterway to stabilize the current gully. The topography indicates flow coming off the field into the wooded area. The basin in mostly row cropped with a small section of woods to the northwest.

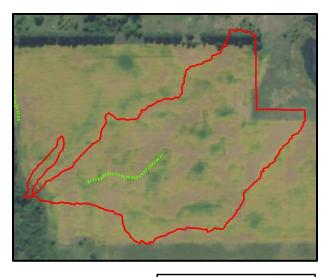
Drainage Area – 10.7 acres Property Ownership – Private Site Specific Information – Aerial imagery indicates agricultural land use. Steepest part of sub-basin is in perennial grass. Construct grassed waterway leading to this region to filter water.

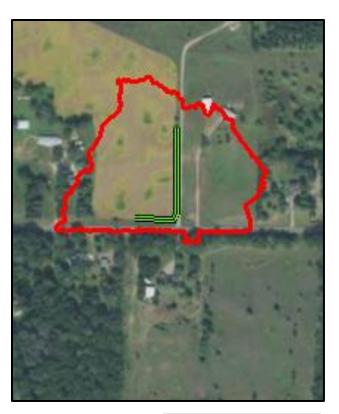
Drainage Area – 8.4 acres Property Ownership – Private Site Specific Information – The area is 50% row cropped and drains to a roadside ditch. Implementing a grassed waterway along the ditch would reduce sediment and nutrient loading into the roadside ditch.

Cost-Benefit						
Practice Cost	P reduction (lb/yr)	\$ per lb TP Removed				
\$413.58	3.41	\$121.28

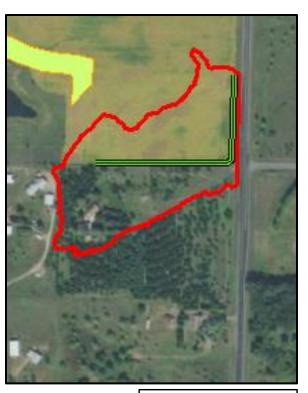
Drainage Area – 8.9 acres Property Ownership – Private Site Specific Information – The area is 50% row cropped and drains to a roadside ditch. Soil data indicated moderate slopping. Implementing a grassed waterway along the ditch would reduce sediment and nutrient loading into the roadside ditch.

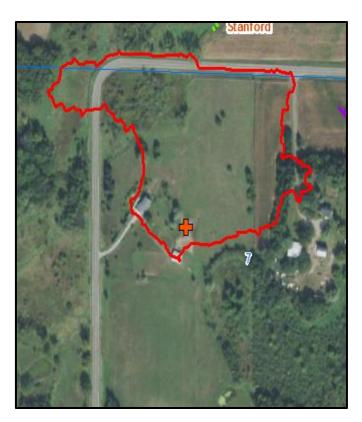
Project ID – Manure Management Zone 5 Sub-Basin 2

Drainage Area – 10.1 acres Property Ownership – Private Site Specific Information – This property has a small hobby farm with what appears to be horses. Manure and runoff management is recommended for this area. More information and engineering data is need to calculate pollution reduction results

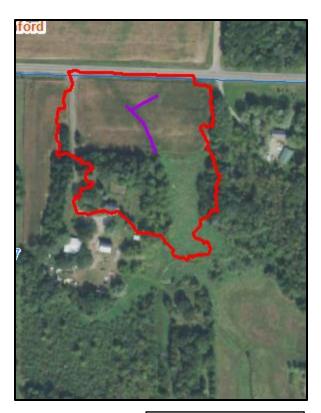
Project ID – Gully Stabilization Zone 5 Sub-Basin 3

Drainage Area – 6.0 acres Property Ownership – Private Site Specific Information – Visible gully has formed on the property within agricultural field. GIS tools indicate steep slopes (7-12%) Address by implementing a grassed waterway to stabilize the current gully as well and trap sediment and nutrients.

Cost-Benefit			
	P reduction		
Practice Cost	(lb/yr)	Removed	
\$1,779.00	4.11	\$432.85

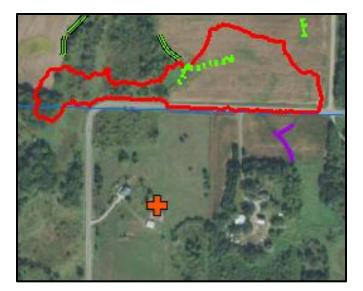
Project ID – Grassed Waterway Zone 5 Sub-Basin 4

Drainage Area – 9.0 acres Property Ownership – Private Site Specific Information – The agricultural field has steep slopes. The field is row cropped with corn and soybeans. Address runoff at concentrated flow path to prevent soil and nutrient loss. The west side of the basin has forested cover.

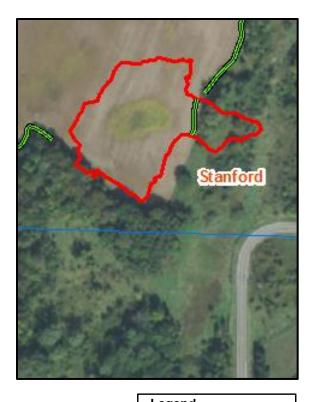
Drainage Area – 2.6 acres Property Ownership – Private Site Specific Information – The area has steep slopes and loamy fine sand soils. Aerial imagery indicates row cropping as the land use. The field edge is adjacent lowland area with a tributary running through it. Implementing a filter strip along the field edge would prevent nutrients and soil from entering the wetland and tributary.

Ci	urrent Conditions	Added Practice		Reduction	
Sub-Basin	6	Туре	Filter Strip	Sediment reduction (t/yr)	0.33
Acros		Shore	50 ft Cool	Soil Loss reduction (t/yr)	0.04
Acres	2.6	Specs	season	5011 LOSS TEURCLION (L/ YI)	0.04
Soil	Sanburn fine sandy loam, 7-18%	Length (ft)	100	Phosphorus reduction (lb/yr)	0.48
2011	slopes	Length (It)	100	Phosphorus reduction (b) yr)	0.40
Slope length (ft)	225	Area (acres)	0.11		
Average slope	4.0	Contr. Area (acres)	1.5

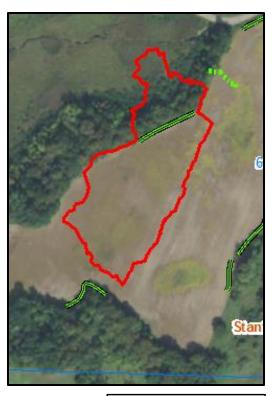
Drainage Area – 4.1 acres Property Ownership – Private Site Specific Information – The area has moderate to steep slopes and loamy fine sand soils. Aerial imagery indicates row cropping as the land use. The field edge is adjacent lowland area with a tributary running through it. Implementing a filter strip along the field edge would prevent nutrients and soil from entering the wetland and tributary.

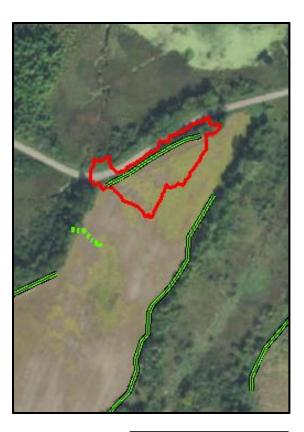
Drainage Area – 1.1 acres Property Ownership – Private Site Specific Information – This basin has steep slopes that drain to the roadside ditch. Implementing a filter strip along the field edge and the ditch would help prevent soil and nutrients from entering the nearby tributaries. The majority of the basin is row cropped.

Cost-Benefit				
	\$ per lb TP			
Practice Cost	(lb/yr)	Removed		
\$264.42	0.96	\$275.44

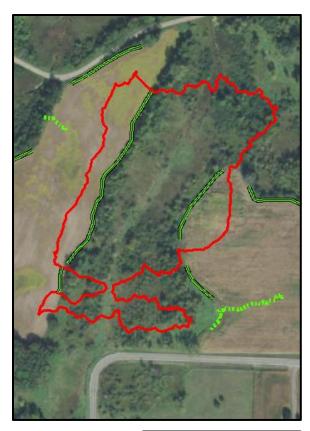
Drainage Area – 12.7 acres Property Ownership – Private Site Specific Information – Most of this basin is lowland area. However, a smaller section is row cropped and has steep slopes adjacent to a nearby tributary. A filter strip would be beneficial in along the field edge to capture nutrients and sediment prior to reaching the lowland.

Cost-Benefit					
	P reduction	\$ per lb TP			
Practice Cost	(lb/yr)	Removed			
\$915.30	3.11	\$294.31

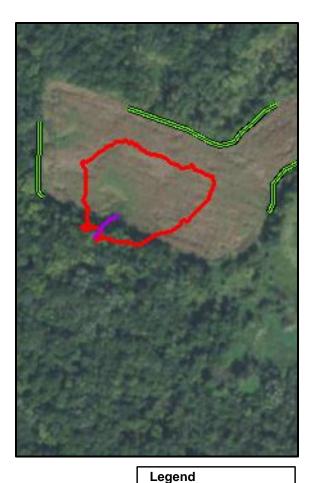
Drainage Area – 1.6 acres. Property Ownership – Private Site Specific Information – Visible gully has formed on property within row cropped field. GIS tools has indicated a nearby stream that would potentially receive sediment and nutrients do to the gully. Address through grassed waterway to stabilize the gully and filter stormwater.

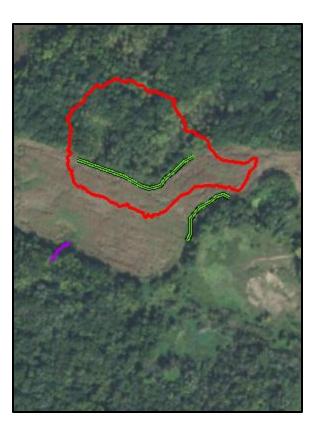
Drainage Area – 4.2 acres Property Ownership – Private Site Specific Information – Steep slopes identified in this area. The basin is 50% row cropped land use and has forest bordering the field to the north. A filter strip along the field boarder would benefit water quality by filtering any stormwater runoff.

Cost-Benefit				
P reduction \$ per lb TF				
<b>Practice Cost</b>	(lb/yr)	Removed		
\$359.34	2.00	\$179.67

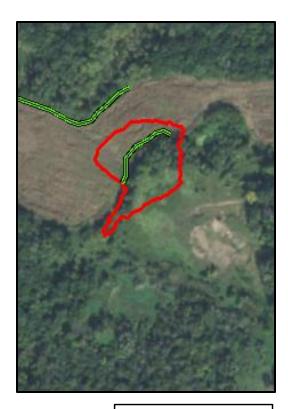
Drainage Area – 1.2 acres Property Ownership – Private Site Specific Information – Steep slopes identified in this area. The basin is 50% row cropped land use and has forest/lowland bordering the field to the south. A filter strip along the field boarder would benefit water quality.

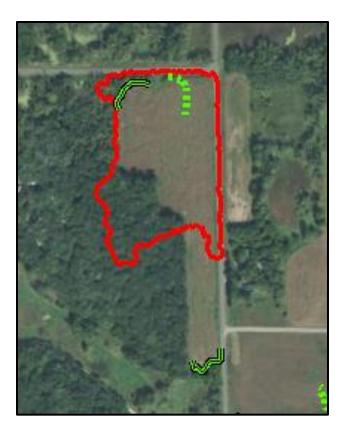
Drainage Area – 10.8 acres Property Ownership – Private Site Specific Information – A small concentrated flow path was indicated at the North West corner of the basin. Because I is a smaller flow path, a filter strip is recommended at the border of the field and the forested area. The filter strip would run perpendicular to the flow path.

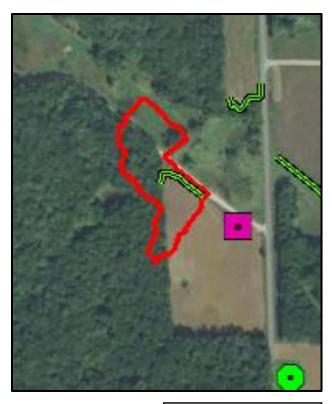
Drainage Area – 3.2 acres. Property Ownership – Private Site Specific Information – This basin is 50% row cropped on the southeast end. There are steep slopes in this area. A filter strip is proposed at the field's edge to the northeast along the road. Field investigations indicate runoff characteristics from the field and across the road.

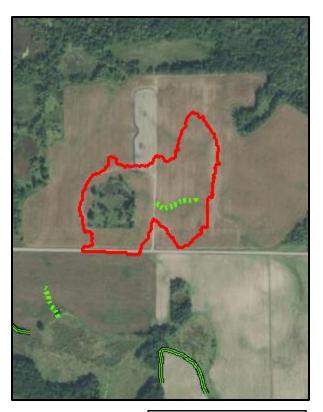
Project ID – Grass Waterway Zone 6 Sub-Basin 6

Drainage Area – 14.5 acres Property Ownership – Private Site Specific Information – With only a small area of the basin being lowland area the majority of it is row cropped. Slopes in the area are moderate and a concentrated flow path was identified. Implementing a grassed waterway along the flow path is proposed.

Cost-Benefit				
Practice Cost	P reduction (lb/yr)	\$ per lb TP Removed		
\$2,016.20	3.55	\$567.94

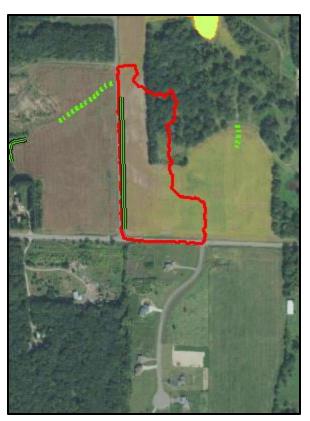
Drainage Area – 12.2 acres Property Ownership – Private Site Specific Information – The majority of the basin is row cropped except for a small portion to the northeast. The entire field slopes towards a drainage ditch on east side of road, making a filter strip a very efficient choice here.

Cost-Benefit			
P reduction (lb/yr)	\$ per lb TP Removed		
1 56	\$166.53		
F

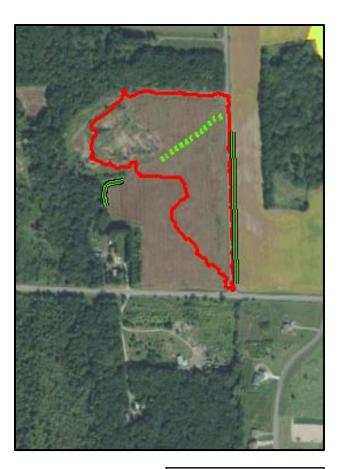
Project ID – Grass Waterway Zone 6 Sub-Basin 14

Drainage Area – 14.0 acres Property Ownership – Private Site Specific Information – The majority of this basin is row cropped. There is a concentrated flow path running down the middle of the basin. GIS tools suggest a gully could form under these conditions. A grassed waterway is proposed for this area.

Cost-Benefit			
Practice Cost	P reduction (lb/yr)	\$ per lb TP Removed	
\$2,905.70	5.51	\$527.35

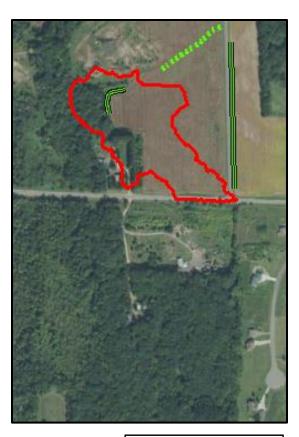
Drainage Area – 10.9 acres Property Ownership – Private Site Specific Information – Basin 15 is about 60% row cropped and the rest forested. A concentrated flow path was identified on the north end of the field running perpendicular to the field's edge. A filter strip is recommended at the edge of the field where the flow path runs.

Cost-Benefit			
Practice Cost	\$ per lb TP Removed		
\$196.62	2.33	\$84.39

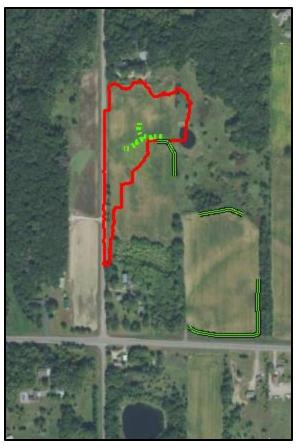
Drainage Area – 7.2 acres Property Ownership – Private Site Specific Information – Steep slopes and an identified concentrated flow path across the row cropped field makes this location ideal for a grassed waterway to be implemented. The majority of the basin is row cropped.

Cost-Benefit				
	P reduction	\$ per lb TP		
Practice Cost (lb/yr)		Removed		
\$3,528.35	5.89	\$599.04

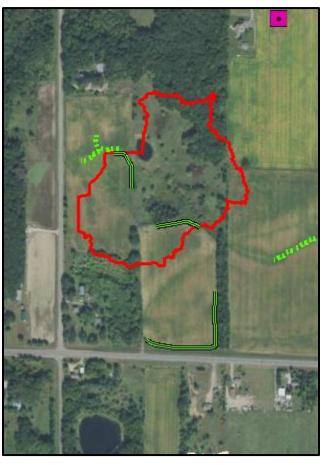
Drainage Area – 19.4 acres. Property Ownership – Private Site Specific Information – This basin is 50% row cropped and 50% forested land. The moderate slopes from the field to the forested land has potential for soil and nutrient erosion. A filter strip along the field edge would trap any nutrients and sediment eroding from the adjacent slope.

Cost-Benefit					
P reduction \$ per lb TF Practice Cost (lb/yr) Removed					
\$250.86	2.47	\$101.56

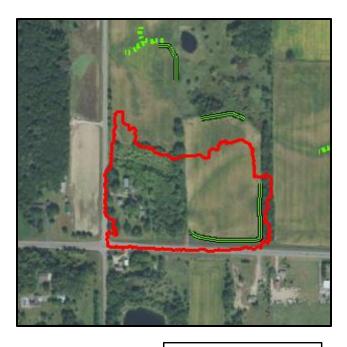
Drainage Area – 17.2 acres. Property Ownership – Private Site Specific Information – Basin 6 is half forested land half row crop land use. Not much slope however a concentrated flow path was identified at the southeast side of the field. A filter strip along the field border would catch and runoff from the field.

Current Conditions		Added Practice		Reduction	
Sub-Basin	6	Туре	Filter Strip	Sediment reduction (t/yr)	2.97
Acres	17.2	Specs	50 ft Cool season	Soil Loss reduction (t/yr)	1.11
Soil	Sanburn fine sandy loam, 2-7% slopes	Length (ft)	855	Phosphorus reduction (lb/yr)	4.01
Slope length (ft)	75	Area (acres)	0.98		N.
Average slope	5.5	Contr. Area (acres)	6.9		CI

Cost-Benefit					
	\$ per lb TP				
Practice Cost	(lb/yr)	Removed			
\$664.44	4.01	\$165.70

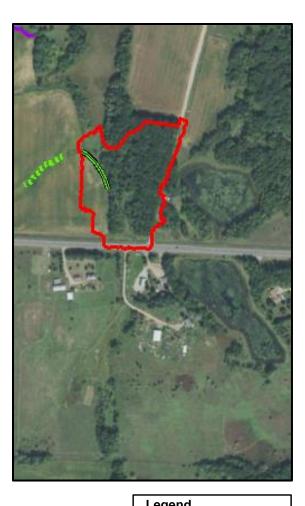
Drainage Area – 8 acres **Property Ownership** – Private Site Specific Information – The majority of basin 8 is forested land. The area to the west of the forest is row cropped and has moderate slope. A filter strip is recommended in the row cropped area where the slope is greatest.

Current Conditions		Added Practice		Reduction	
Sub-Basin	8	Туре	Filter Strip	Sediment reduction (t/yr)	0.61
Acres	8	Specs	50 ft Cool season	Soil Loss reduction (t/yr)	0.37
Soil	Emmert loamy fine sand, 12-25% slopes	Length (ft)	280	Phosphorus reduction (lb/yr)	0.83
Slope length (ft)	65	Area (acres)	0.32		<u> </u>
Average slope	6.1	Contr. Area (acres)	1.2		C

Cost-Benefit				
P reduction \$ per lb TP				
<b>Practice Cost</b>	(lb/yr)	Removed		
\$216.96	0.83	\$261.40

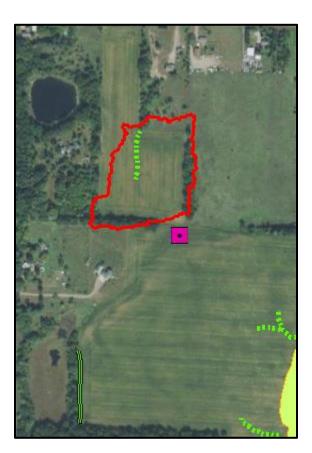
Drainage Area – 7.8 acres **Property Ownership** – Private Site Specific Information – The majority of this basin is row cropped and has moderate slope. A stream network was identified and I runs perpendicular to contour lines which indicates the potential for a gully formation. A grassed waterway is recommended to stabilize the soil and prevent nutrient loss into the nearby lowland.

Current Conditions		Added Pra	octice	Reduction	
Sub-Basin	1	Туре	Grassed waterway	Sediment reduction (t/yr)	3.16
Acres	7.8	Contributing acres	6.5	Soil Loss reduction (t/yr)	11.00
Soil	Sanburn fine sandy loam, 2-7% slopes	Vol Voided (ft ³ )	200	Phosphorus reduction (lb/yr)	2.69
Slope length (ft)	100	Length (ft)	200		1
Average slope	2.5	Area (acres)	0.23		
		Years	1		
		Distance to SW (ft)	415		C

Cost-Benefit		
Practice Cost	P reduction (lb/yr)	\$ per lb TP Removed
\$1,186.00	2.69	\$440.89

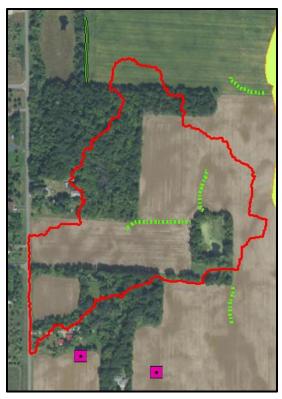
Drainage Area – 39.5 acres Property Ownership – Private Site Specific Information – Two concentrated flow paths lead towards wetland pond. The flow paths travel over the row cropped field. A grassed waterway would help prevent soil and nutrient loading into the adjacent wetland. The majority of the basin is row cropped but has areas of forest and wetland

Cost-Benefit		
Practice Cost	P reduction (lb/yr)	\$ per lb TP Removed
\$2,787.10	7.34	\$379.71

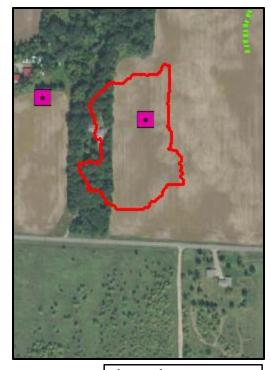
Drainage Area – 6.1 acres Property Ownership – Private Site Specific Information – The row cropped field has steep slopes and concentrated flow path following a contour depression. Implementing a WASCOB to allow for water infiltration would benefit the water quality in this area. The majority of the basin is row cropped.

Cost-Benefit				
Practice Cost	P reduction (lb/yr)	\$ per lb TP Removed		
\$9,803.70	0.80	\$12,254.63

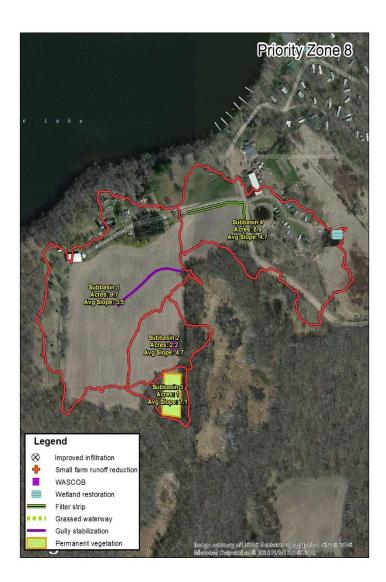
Priority Zone 8 is a bit small in size, however given its very close proximity to the lake and the eastern tributary along with signs of gully formation in its sole agricultural field this location was highlighted in the Targeting study and is considered high priority. The slopes are largely moderate (3%-4%) in this region with the exception of a single sub-basin in which slopes of 7% and greater are noted.

Priority Zone 8 Summary		
Acres addressed	19.9	
Dominant Land Cover	Agricultural	
Total Sub-Basins	4	
Potential BMPs	5	
Potential TP reduction (lb/yr) 16.48		
Potential TSS reduction (tons/yr)

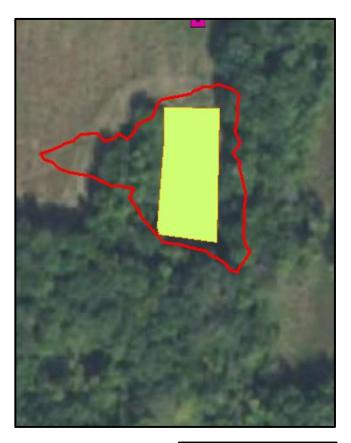
Project ID – Permanent Vegetation Zone 8 Sub-Basin 3

Drainage Area – 1.0 acres Property Ownership – Private Site Specific Information – Steep slopes indicated by NRCS topography data provides valid information the implementing permanent vegetation on the hillside would prevent soil and nutrient loss into the adjacent wetland.

Cost-Benefit				
P reduction Practice Cost (lb/yr)		\$ per lb TP Removed		
\$407.00	0.72	\$565.28

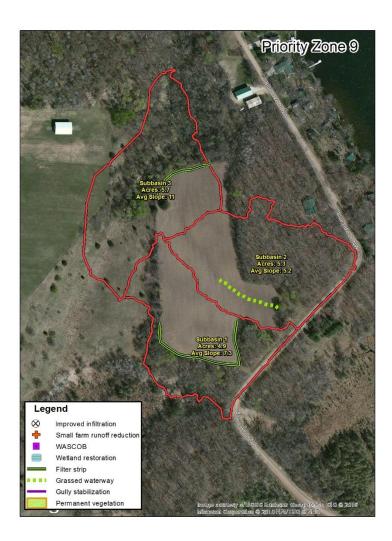
Priority Zone 9 is the smallest of all the targeted zones in the Blue Lake Watershed, at only 16 acres. However, the area is quite close to the southwestern side of the lake and holds slopes ranging from 5% to 11%, making it a prime candidate for conservation work. There is a row cropped field located in the middle of the Zone and there has been three areas identified that would benefit from a BMP implementation.

Priority Zone 1 Summary				
Acres addressed	15.9			
Dominant Land Cover	Agricultural			
Total Sub-Basins	3			
Potential BMPs	3			
Potential TP reduction	5.00			
(lb/yr)	5.00			
Potential TSS	4.97			
reduction (tons/yr)	4.97

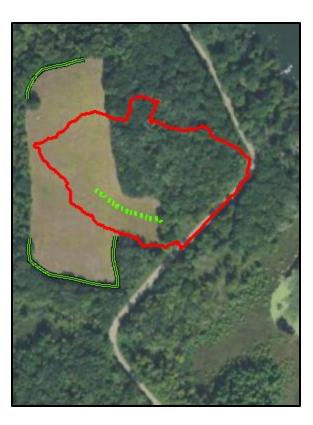
Drainage Area – 5.3 acres Property Ownership – Private Site Specific Information – This basin is half row cropped half forested. GIS tools indicated a concentrated flow path flowing southeast towards the lake. The topography indicates land conditions are prime for gully formation. Implementing a grassed waterway would reduce the chances of gully formation and protect the areas water quality.

Cost-Benefit				
Practice Cost	P reduction (lb/yr)	\$ per lb TP Removed		
\$9,803.70	2.86	\$3,427.87

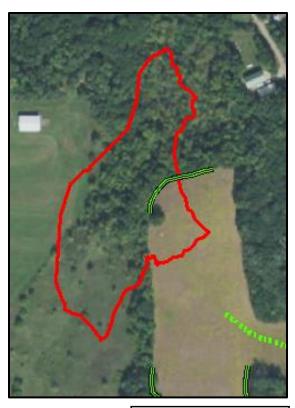
Drainage Area – 5.7 acres Property Ownership – Private Site Specific Information – A small section of this basin is row cropped. The agricultural field bumps up to forest. A filter strip is recommended at the field edge where slope is steepest. The majority of the basin is forested with only a small portion being row cropped.

Cost-Benefit						
Practice Cost		\$ per lb TP Removed				
\$210.18	0.84	\$250.21
